Z14 TECHNICAL INSTRUCTIONS

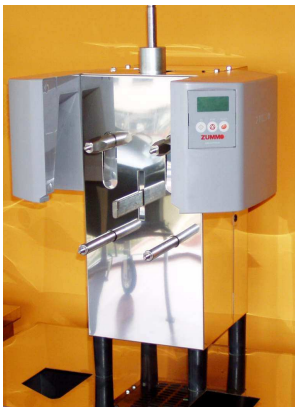
1

Remove all the external parts (Fig. 1)

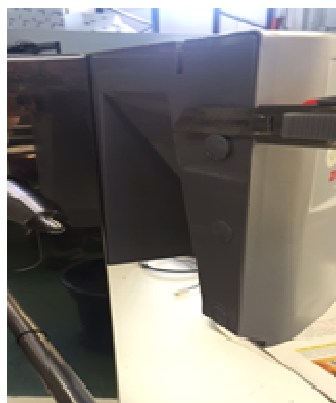
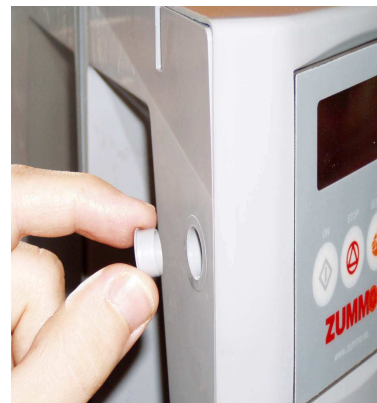
Extract the right-hand side plate top plug. (Fig. 2 and 2b)

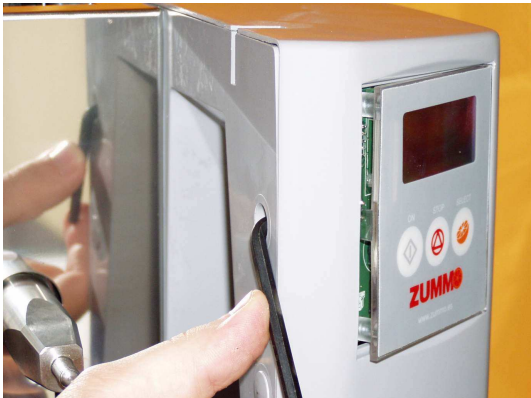
3

Extract the electronic circuit board by pressing with the short end of a No.5 Allen key on the circuit board tab. (Fig. 3)

N.B. Insert the short end of the key (Fig. 3), do not use punches or screwdrivers as these may damage the electronic circuit board.

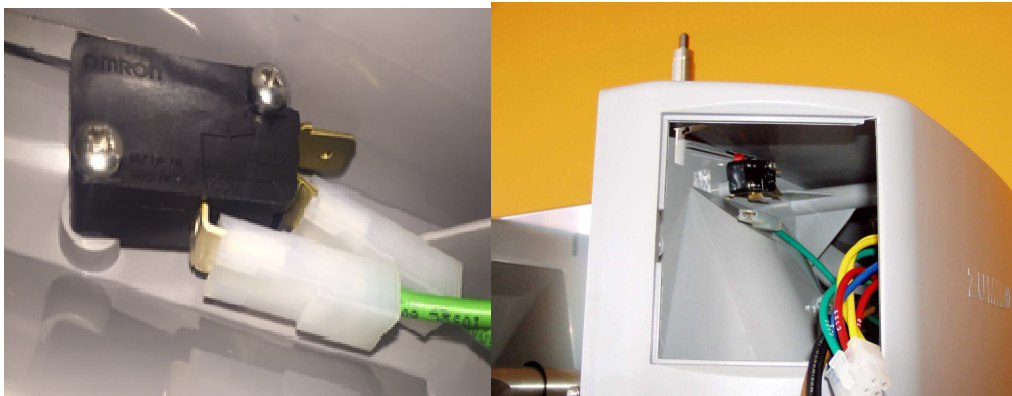
4

Remove the board completely from the machine.
Disconnect the wires from the short micrometer. (Fig. 4)
Extract the wiring from inside the side plate.
Extract the front of the machine.

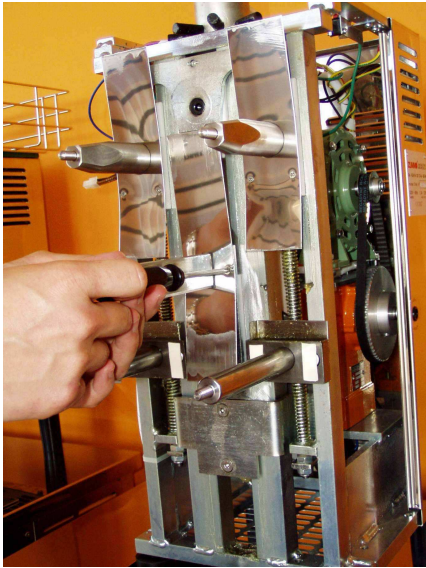
5

Extract the three runner covers (to be able to work safely). (Fig. 5)

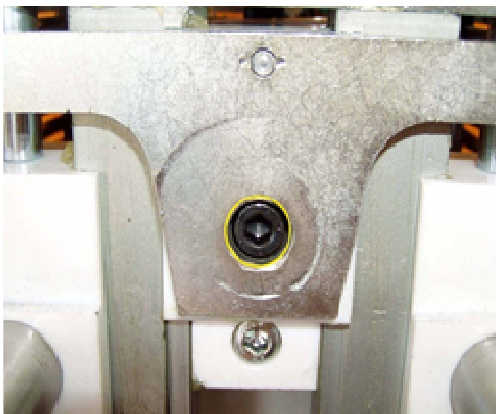
6

(fig. 6)

. (Fig. 6)

Extract the bottom bolt from the bridge, thereby releasing it. (Fig. 6)

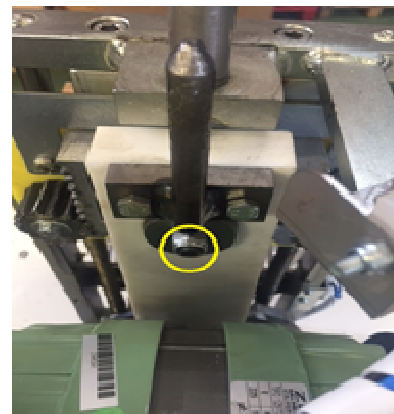
7

While blocking the Allen screw extract the hexagonal brake torque (fig.7)

with the aid of a screwdriver. (Fig. 7)

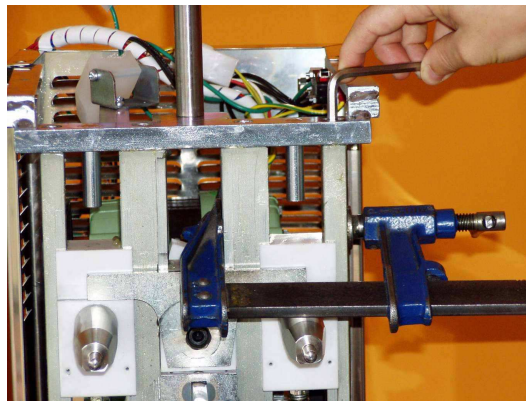
runner and the bars guiding it, this play needs to be reduced. To do so, loosen the top chassis bolt corresponding to the outer bar of this runner, lower the runners as in Photo 8 and retighten the bolt but with the bar held closed with the aid of a clamp. You should then check that it has not been closed too much. The runner should rise and fall smoothly without catching.

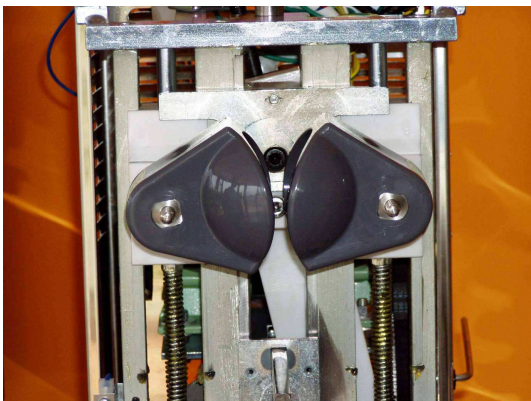
9

tab and turn the cups in reverse direction (turn the reducer pulley in a clockwise direction) until the cups are facing each other. (Fig. 9)

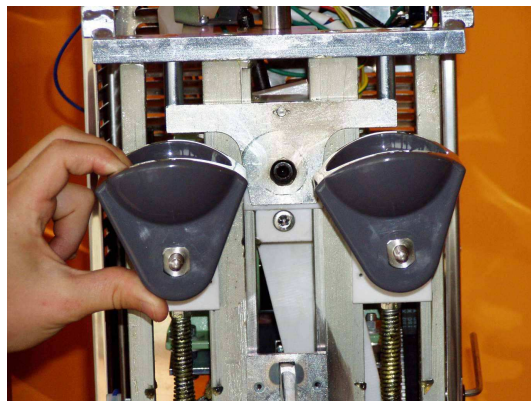
10

Raise the cups by hand to the vertical position and release them (Fig.10). The cups should rise and fall freely without any stiffness of movement. If they move stiffly, the guides, the runners hole and the cups shafts should be cleaned and greased.

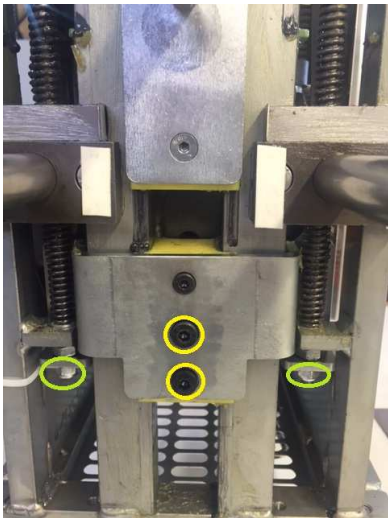
11

These are small head Allen type screws; 6x30, the bolt below and 6x16 the above one, (fig 11). In versions of 2015 towards nowadays it had 3 bolts (up of 6x16, middle 8x16 and below of 8x30).The screw below fastens the lower bearing and the other fastens runner.

and extract the runner with its rod. The rod has to be released from the two bottom bolts (spotted in green on the picture 11)

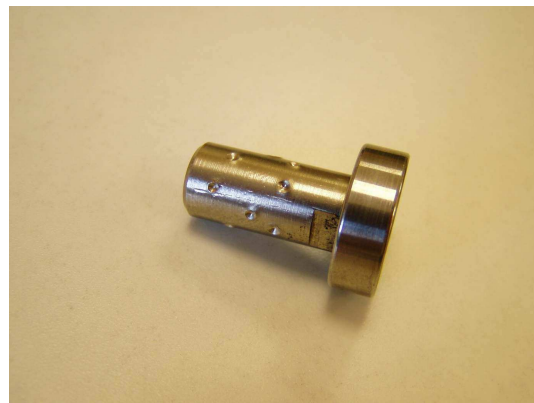
12

allows the bottom bearing to be extracted. Once the bearing has been changed verify that the pin with the bearing remains fitted to the runner, with no play. If play is detected, extract it and use a punch to produce protuberances (Fig. 12) in order to eliminate this play.

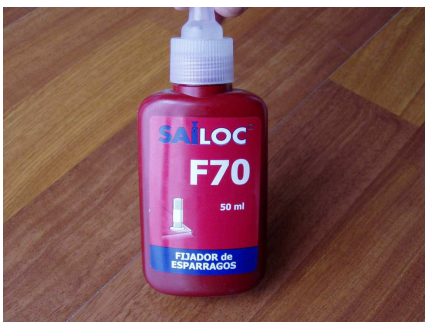
Apply thread-locking adhesive to the bolt threads (Fig. 13 and 14) and fit them.

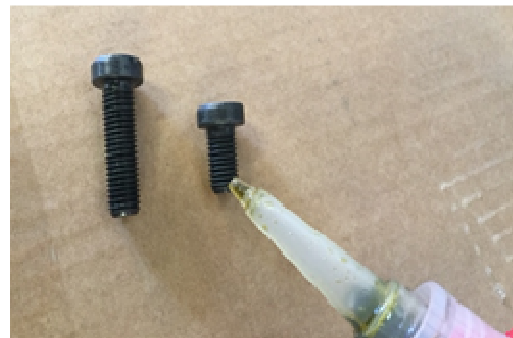
14

TAKE CARE WHEN TIGHTENING THE TOP BOLT, AS IT IS THREADED DIRECTLY ONTO PLASTIC AND COULD PASS THROUGH IT

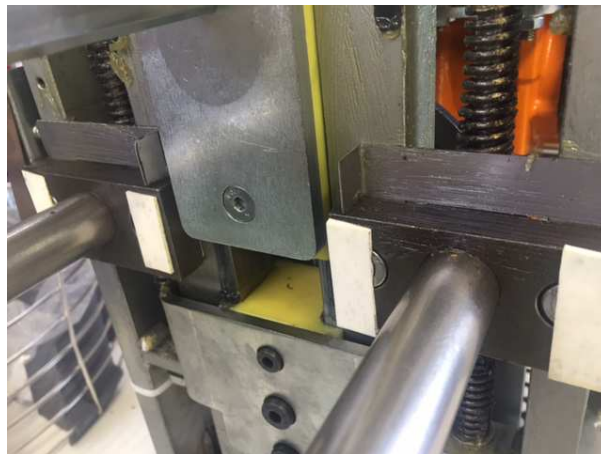
These parts (reference Nos. 1405017 and 1405018) are to prevent the juice entering through the cup runner covers from reaching the central guides.

If your machine does not have these parts, they should be fitted. It is simply a question of fitting them as in Photo 15 and greasing the joints to prevent the juice from leaking through the slots.

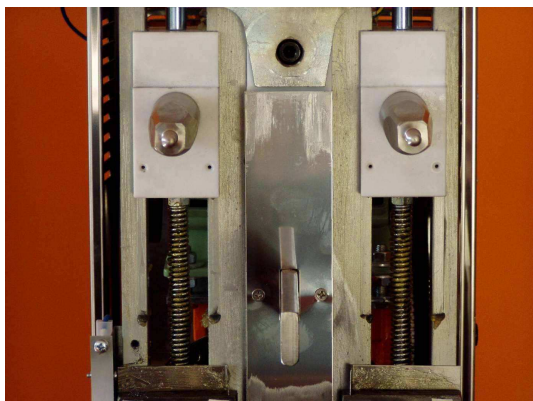
16

This part originally measured 214mm (Fig. 16) and was later lengthened to 230mm (Fig. 17). This change was made from machine No. 2077001 onwards, and the new one can be distinguished by its rounded edges. (Fig.17)

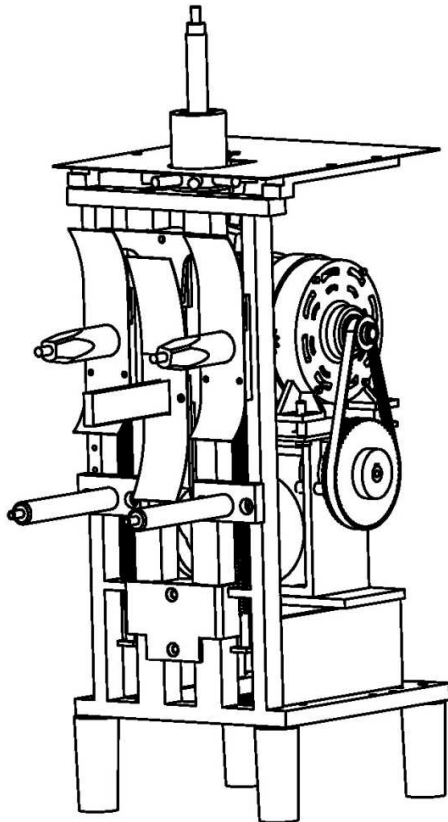
18

If your machine is fitted with the short one, it should be replaced with the new model. The three runner covers have to be bent slightly forwards by around 20mm (Figure 18), and at the front, grease should be added in the area where they rub (Figure 19).

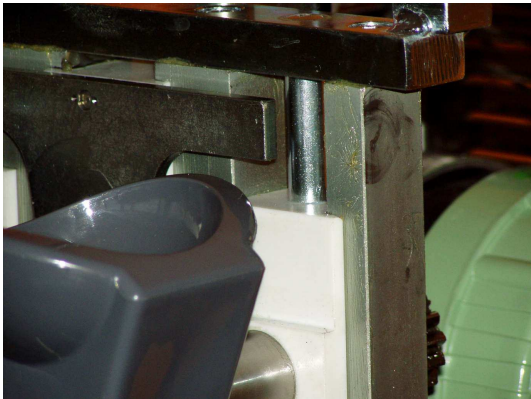
20

Move the cups to the vertical position. The runners should be touching the top end stops. (Fig. 20)

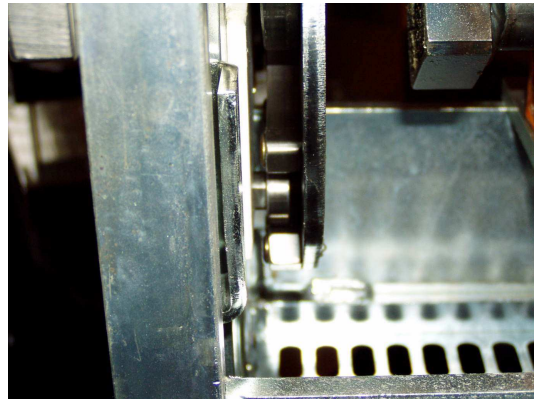
21

Turn the reducer pulley anticlockwise and observe how the sectors of the copier

move towards the bottom bearing. (Fig. 21)

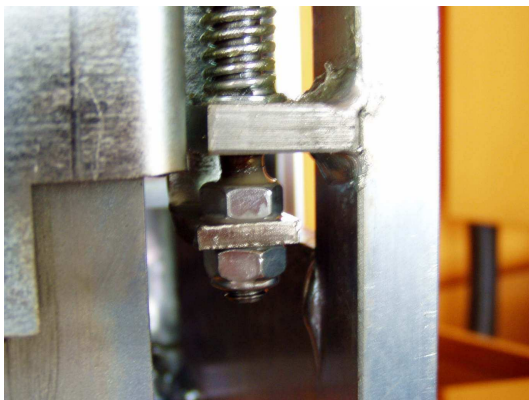
22

The bearing needs to be raised or lowered by adjusting the bottom nuts on the pullers (Fig. 22), so that the bearing enters the copier barely touching it. Keep turning the reducer pulley, and at the point where the cups stop turning and begin their descent, **they should be facing each other (Fig. 24 and 25), at the same level, and the runners should come away from the end stops at the same time (Fig. 23)**

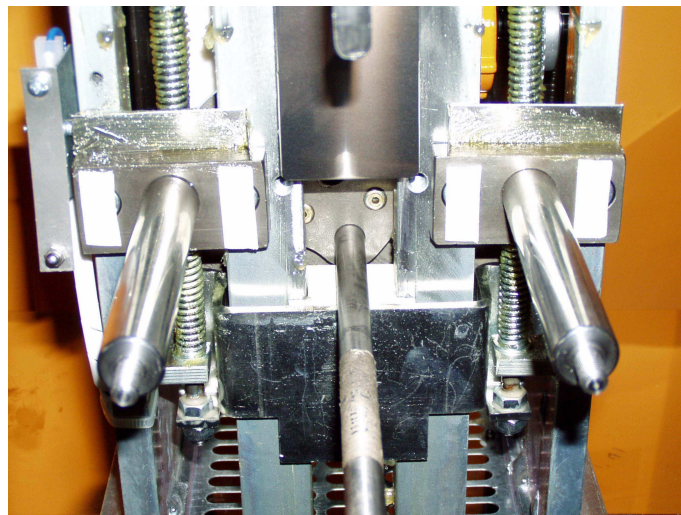
26

In these three cases the reducer needs to be released from its position, however, the most important point is that when refitting the reducer, the center of the reducer must be aligned perfectly with the center of the chassis. To do so, use a 12Ø rod inserted into the reducer shaft. This should be centered between the two central bars of the chassis. (a 12Ø drill bit can be used) (Fig. 26)

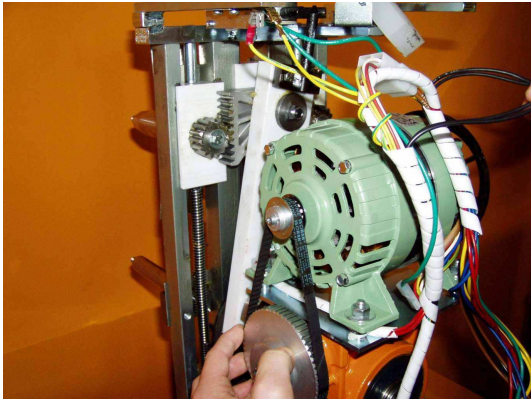
27

to its highest point and position it completely vertically. To do so, turn the reducer pulley until this is achieved. (Fig. 27)

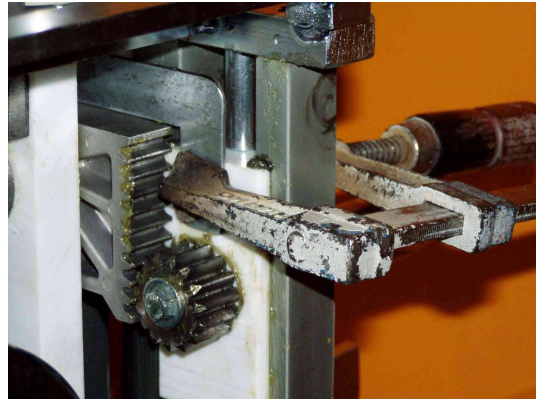
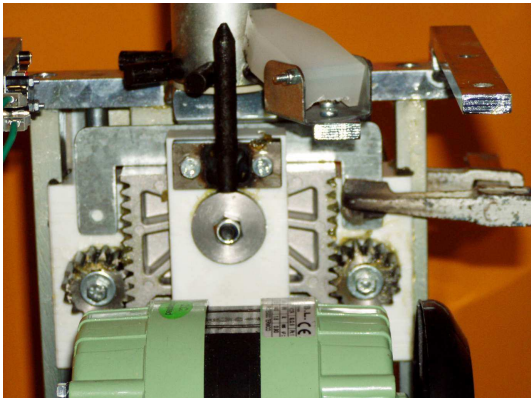
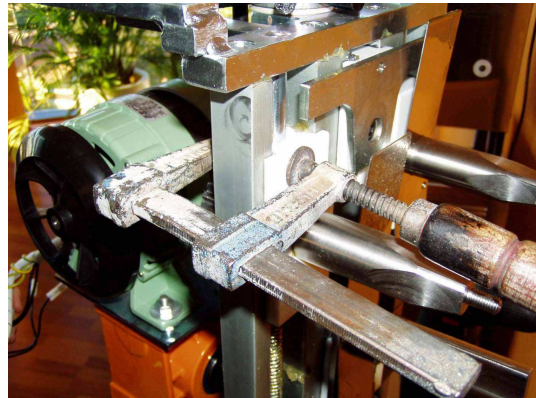
Once the rod is at its highest position, fit the new part. This should rest on the bridge and be centered, and held in place using a clamp (Figs. 28, 29, 30) to

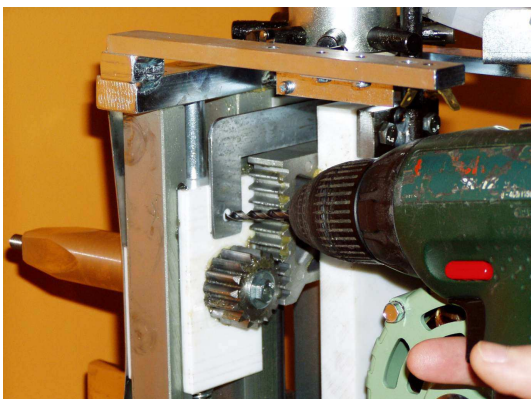
31

Drill 4.75Ø holes to a depth of 25mm. (Fig. 31)
The motor will prevent the holes from being drilled completely horizontally, however this is not important.

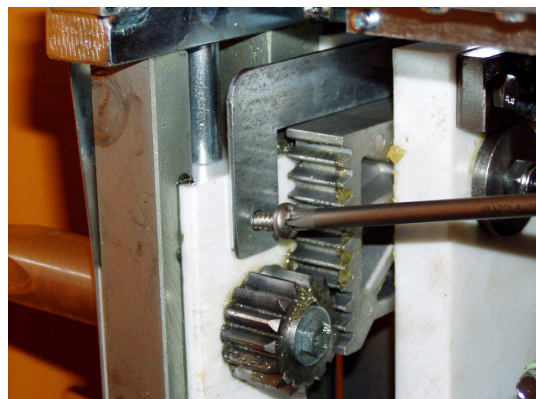
32

Fit the screws (Fig. 32). They must not be over-tightened.

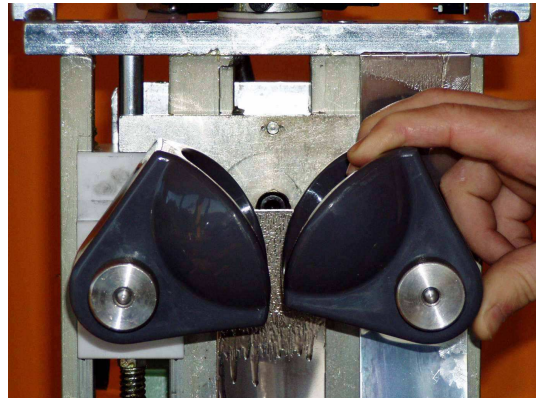
36

Turn the reducer pulley clockwise until the cups are horizontal. Turn the cups by hand to the vertical position and release them (Fig. 36). On releasing them, the runners should reach the top end stop under the action of the springs, without manual assistance. Grease the runners and the springs if necessary.

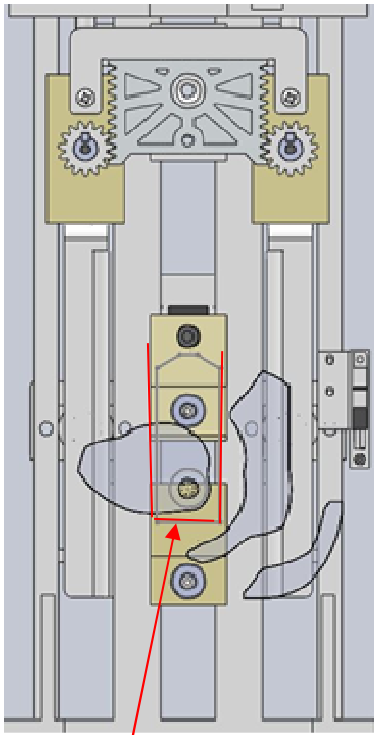
Gearbox shaft at 0°

11.1.- For setting up the cups runners and the copier we first fit both cups in the vertical position. While having the cups in the vertical position, the bearing will remain faced at the entrance of the copier slot.

With the gearbox shaft at 0°, we will balance the bearing in that way, achieving that it doesn't touch the upper side of the slot.

The bearing must remain faced as seen on the picture.

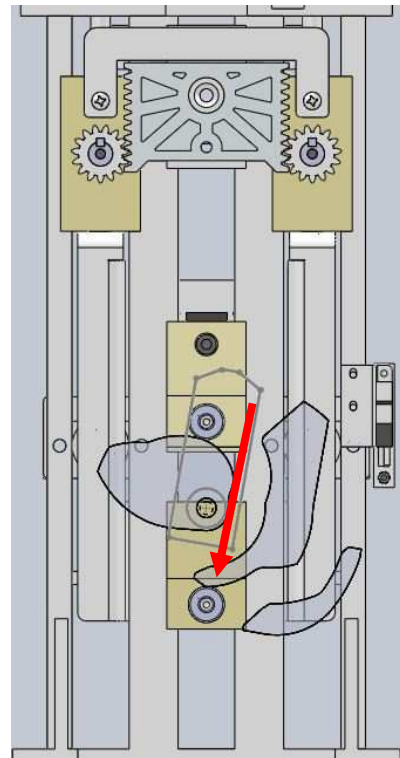
11.2.- When the gearbox shaft will be at 10° the bearing starts getting inside the copier slot. It never has to touch the upper side of the copier and the lower side only has to rub against the bearing.

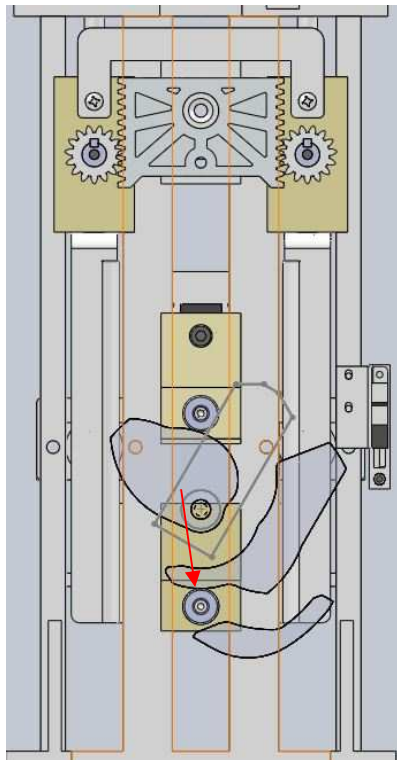
11.3.- When the gearbox shaft will be at 30° , if the bearing is well fitted, it will pass rubbing against the lower side of the copier and will remain closer to the upper edge but without rubbing so much. With this initial adjustment, we will avoid an extra effort of the bearing while the process is running and we will gain durability of all the assembly.

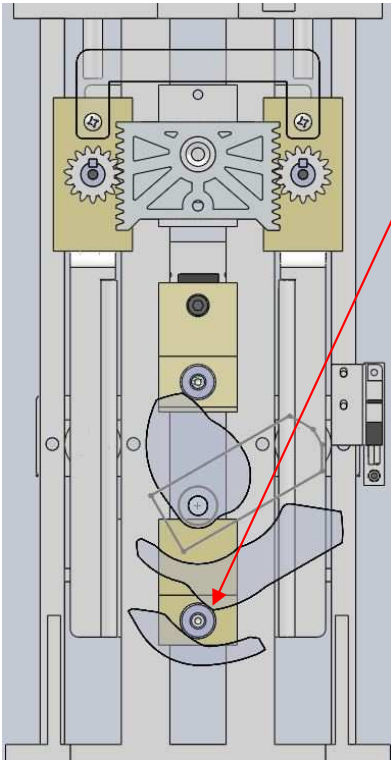
When the copier shaft will be at 60°, the cups start going down already and the bearing will be at the middle of the process (see picture beside). As we see the bearing about to leave the copier slot and it should pass through it with the minimum rub possible.

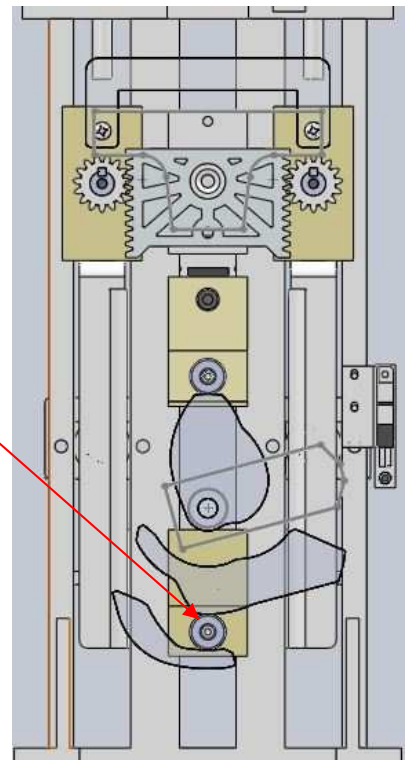
At the cutting moment, the copier will be at the same position as in the picture. The blade will be at its higher position. In the event of the machine blocked at this moment of the process, we must check that the exit of the bearing through the end of the copier slot is well fitted and check if the bearing is at the right place.
